WE-2024-01 – Rodney WPCP Upgrades

Addendum No. 1

**HAZARDOUS MATERIALS SURVEY
RODNEY WASTEWATER TREATMENT PLANT
22590 Pioneer Line
Rodney, Ontario
N0L 2C0**

Project No: L24-03898

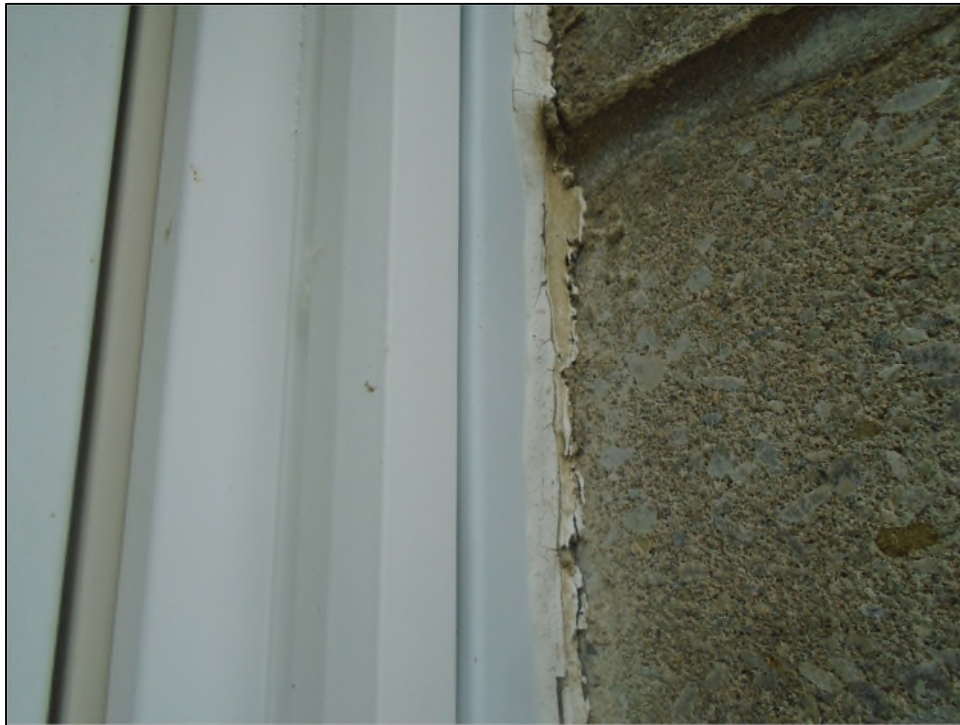
- Samples Caulk-A-01/02/03 were collected of grey window, door and vent caulking from the exterior of Control Building A. The caulking was found to contain 1% Chrysotile asbestos.
- Samples Caulk-B-01/02/03 were collected of white door and vent caulking from the exterior of the Screen Building. No asbestos was detected in the samples.
- Samples Caulk-C-01/02/03 were collected of white door and vent caulking from the exterior of Control Building B. No asbestos was detected in the samples.
- Samples Caulk-D-01/02/03 were collected of white caulking on the pump shed associated with the Aerator Basins. No asbestos was detected in the samples.
- Samples Caulk-E-01/02/03 were collected of black caulking on piping associated with Aerator Basin #1. No asbestos was detected in the samples.

Photograph 1: View of asbestos-containing grey window, door and vent caulking on the exterior of Control Building A, assigned a **Priority 2**.

Non-friable ACM assigned a Priority 1 must be removed and/or repaired immediately following applicable asbestos abatement procedures. Non-friable ACM assigned a Priority 2 can remain in place until major system upgrading, maintenance or demolition which could result in disturbance of this material. In the event the non-friable ACM is removed, Type 1 operations apply (provided that the material is wetted down and removed using non-powered handheld tools) as outlined in Ontario Regulation 278/05, *Designated Substance - Asbestos on Construction Projects and in Buildings and Repair Operations* – made under the Ontario Occupational Health and Safety Act.
